Docket No. 217 – Development and Management Plan Inspection

Northeast Utilities Service Company Certificate of Environmental Compatibility and Public Need for the construction of a 345-kV electric transmission line and reconstruction of an existing 115-kV electric transmission line between Connecticut Light and Power Company's Plumtree Substation in Bethel, through the towns of Redding, Weston, and Wilton, and to the Norwalk Substation in Norwalk, Connecticut.

Date: May 10, 2006

Location: Transition Stations: Hoyts Hill, Archers Lane, Norwalk Junction

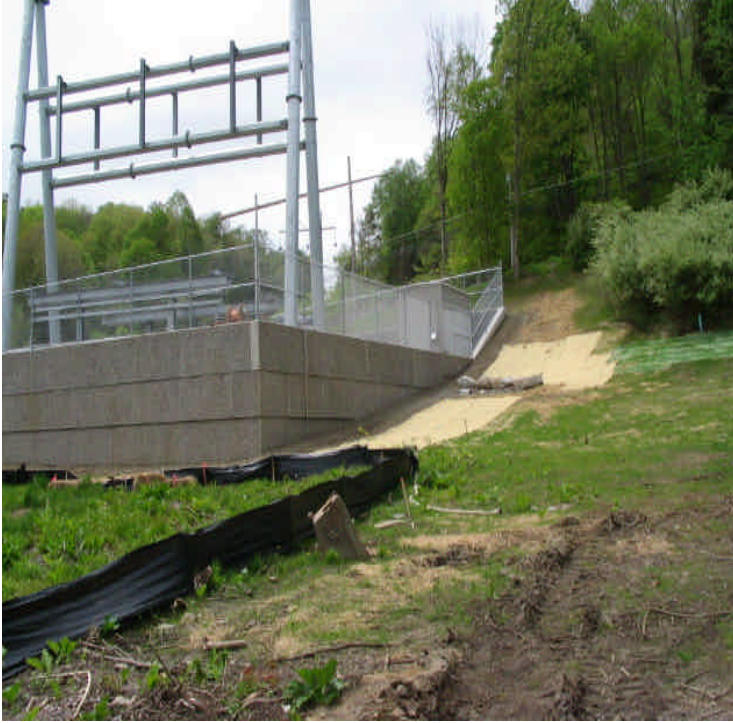
Hoyts Hill Transition Station: Photo on the left shows the restored northern slope. Contractors repaired the tracks they made in the EC mats. Photo on the right shows where the grounding work was backfilled with no disturbance to the adjacent area. 5/10/06

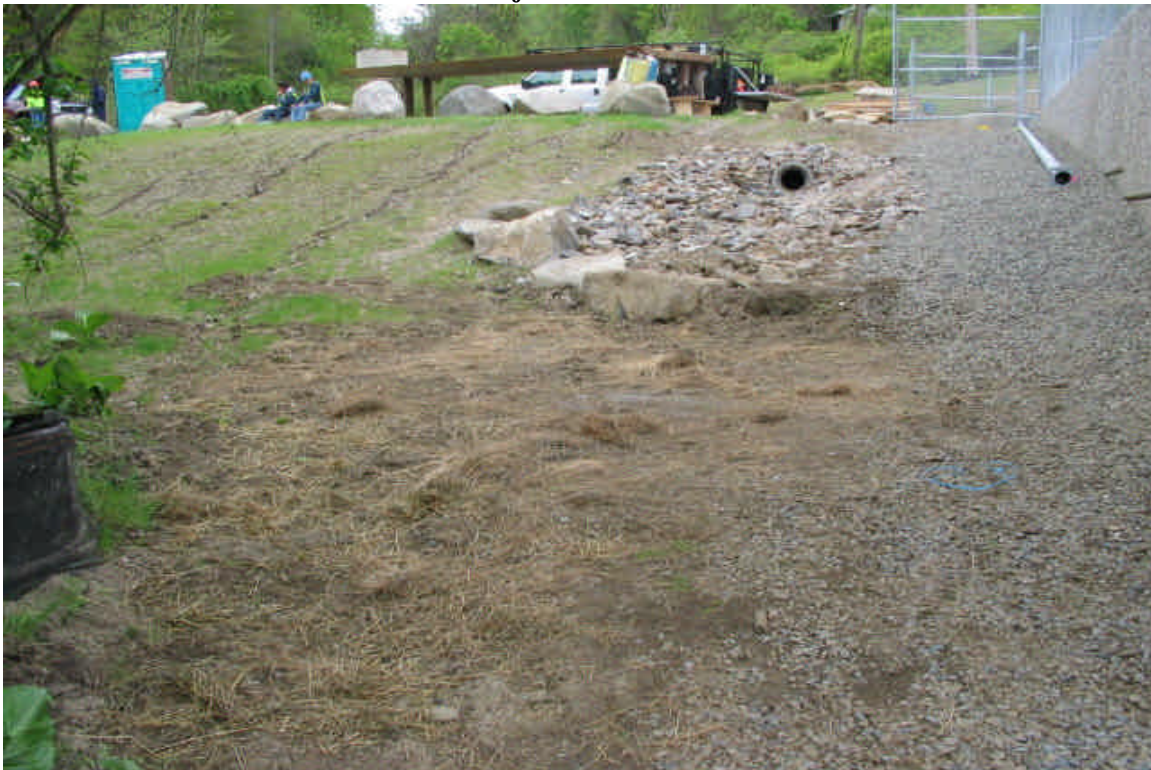
Photo shows where the largest gully on the southern slope was filled in and restored. Continue to monitor for stabilization along this slope. 5/10/06.

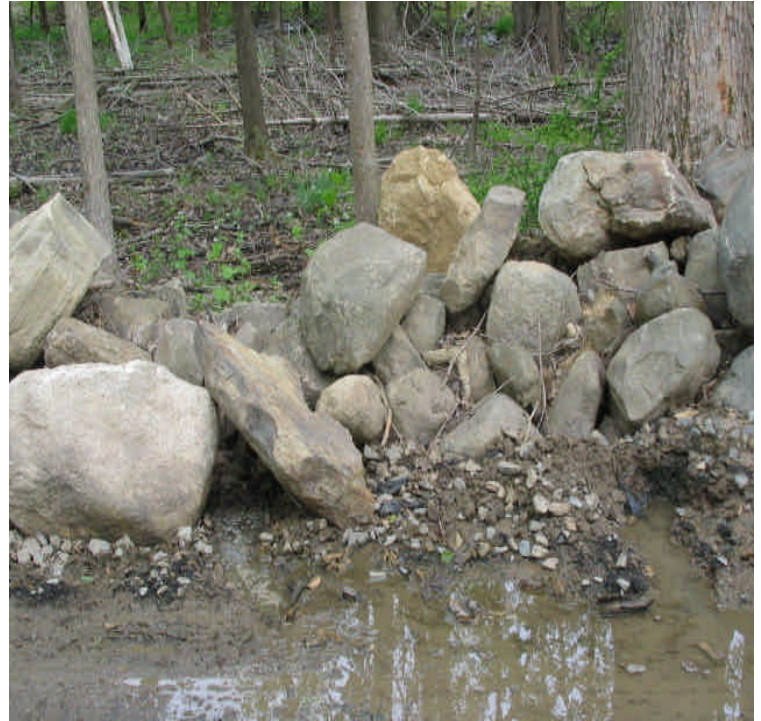
Archers Lane: Photo on the left shows a view of the station pad with structures being installed. Photo on the right shows the stone wall along the access drive. Minor amounts of water and sediment were filtering through here but it was not impacting the wetland. 5/10/06.

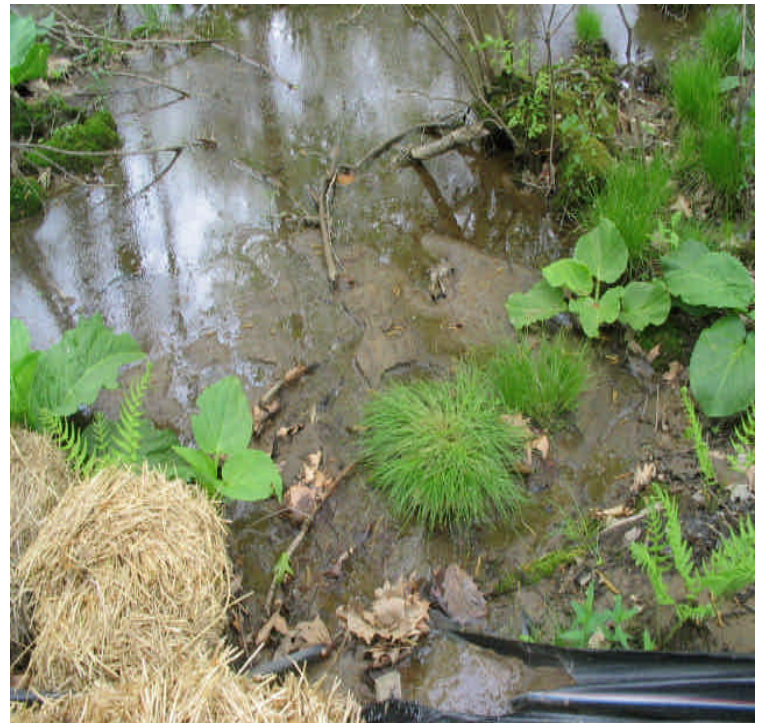
Photo on the left shows the view of the station from the ROW. Photo on the right shows the 1st wetland crossing near the station. Sediment still needs to be removed carefully by hand where obvious deposits have built up. Some spots have 6" or more of accumulated silt from the access drive. 5/10/06.

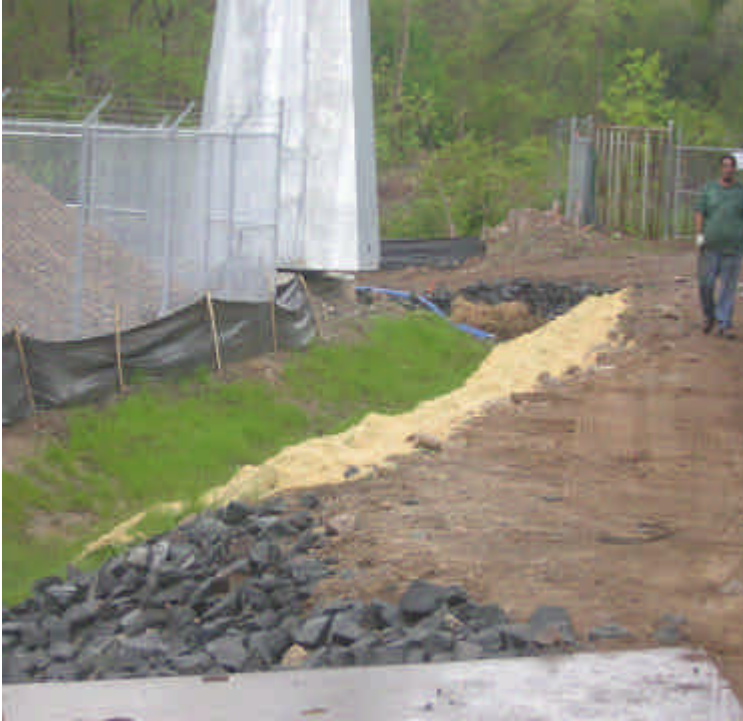
Norwalk Junction: Photo on the left shows the recently restored slope of the swale. EC matting remains in good shape. Photo on the right shows minor dewatering with haybales in place to filter out sediment prior to going to the wetland. 5/10/06.

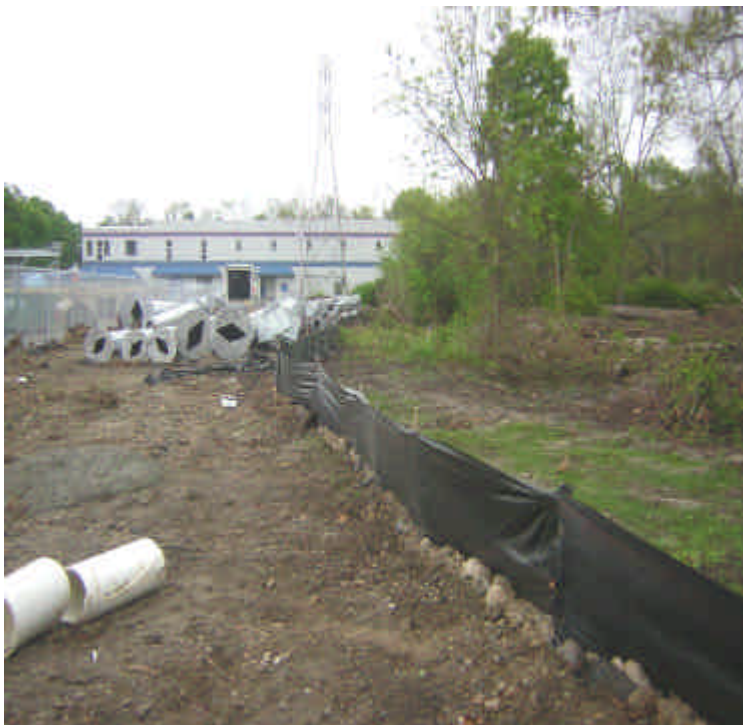
Photo on the left shows the well restored perimeter silt fence along the river. The area between the fence and the river was restored with seed and vegetative growth has started. Photo on the right shows a view of some of the ongoing foundation work within the yard. 5/10/06.
